Fracture Surface Analysis of Optical Fibers

John J. Mecholsky, Department of Materials Science & Engineering, University of Florida

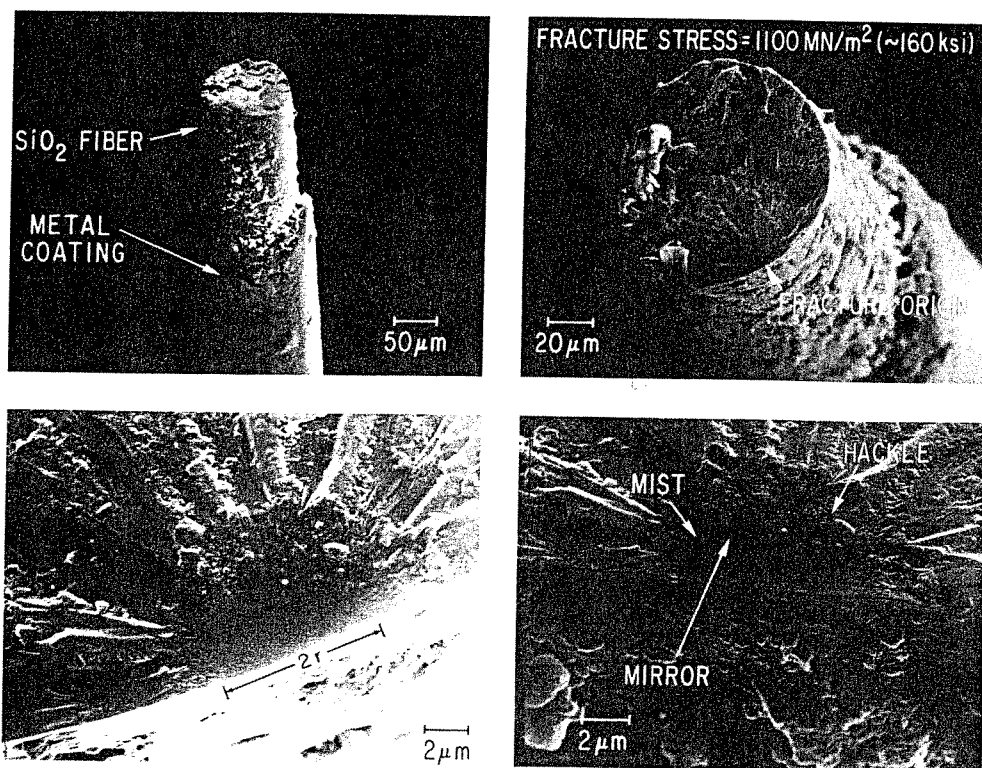
Fig 3 Scanning electron microscope (SEM) fractographs of a metal-coated fiber showing fracture demarcations surrounding the fracture origin (most likely a sharp crack—not visible on the surface)

Stress Analysis. Figure 3 shows a metal-coated fiber that demonstrated the classic mirror, mist, and hackle region schematically represented in Fig 1. The fracture origin in this fiber was most likely a sharp crack that could not be observed; however, by measurement of the mirror-mist boundary, Eq 1 was used to determine the stress (1100 MPa, or 160 ksi) which agreed with that recorded by a load cell. The critical defect size was estimated from Eq 2 to be $0.3 \mu\text{m}$. The fiber shown in Fig 4 was fractured in a drum-to-drum proof stress at 1400 MPa (200 ksi). The failure stress inferred from the drag load

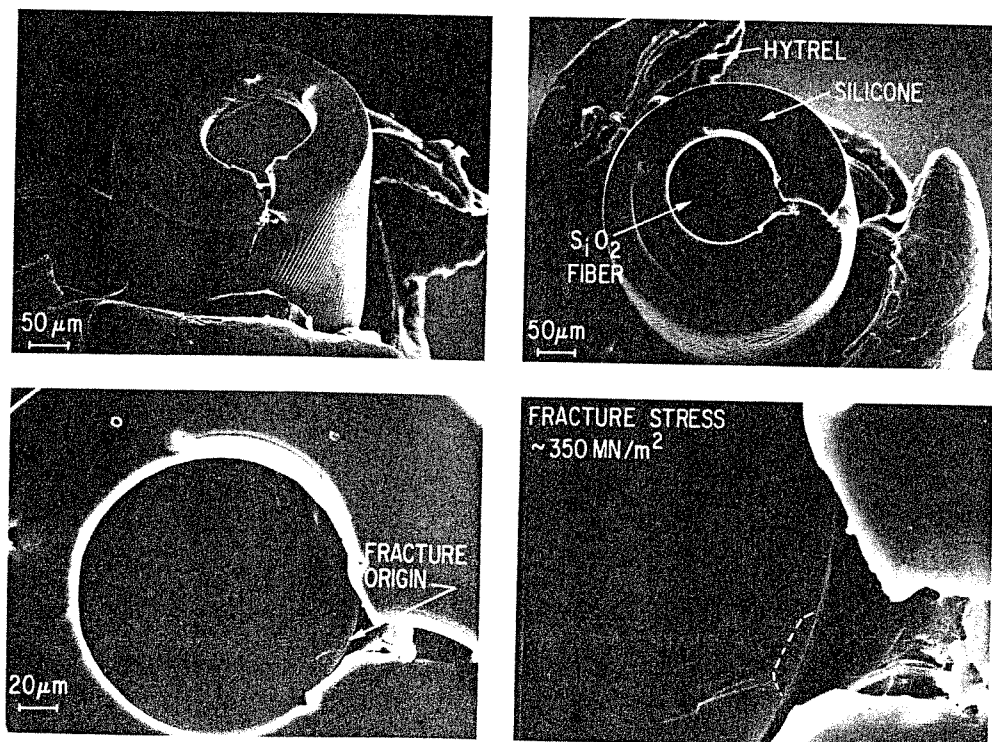
Fig 4 SEM fractographs of a fiber that failed from a sharp crack at the surface (dotted line in lower right fractograph). This fiber failed well below the proof stress of 1400 MPa (200 ksi) indicating failure on the edge of the drum before full stress was achieved.

between the drums and the fiber dimension was 1400 MPa (200 ksi). However, the fracture surface measurements indicate a failure stress of 350 MPa (50 ksi). The difference is apparently due to the fact that failure occurred while that point of the fiber was still in contact with the drum, that is, before it had experienced the full drag load. Without fracture surface examination, it could only be concluded that a stress of 1400 MPa (200 ksi) or less was achieved on fibers failing during proof testing. The main point is that, regardless of the source of loading (mechanical or thermal), in most cases Eq 1 or 3 can be used to determine the stress at failure from the fracture surface.

Flaw Identification. Most of the fracture origins that could be identified (approximately 50) were surface failures. One of the surface failures was a result of a foreign particle (Fig 5A); the remainder resulted from cracks or mechanically induced chips (Fig 4) and "unidentified" sources of failure (Fig 6). It was suspected that at least four of the five fracture origins listed are from small crystallite formations, but this was not determined for certain. The handling or mechanically induced cracks were generally easy to identify and measure (Fig 4). There was generally good correlation between observation and that expected from Eq 1 and 2 (Ref 10).

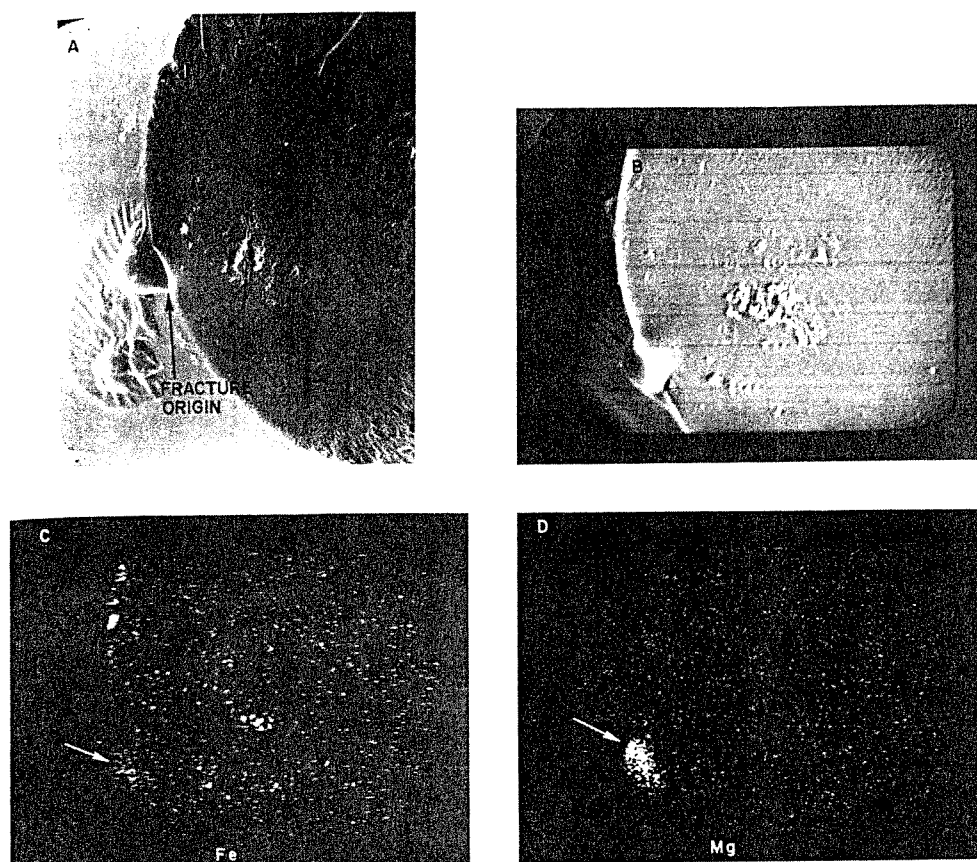
Fig 5 Fiber failure due to a foreign particle. (A) SEM fractograph of a polymer-coated fiber that failed in proof test at 1400 MPa (200 ksi). (B) Real image of A as given by microprobe unit. (C and D) Microprobe electron images showing relative concentrations of Fe and Mg, respectively. Arrows indicate fracture origin (crack between foreign "dust" particle and bulk SiO₂) for reference. The mirror-size measurements indicate a failure stress of ~315 MPa (~45 ksi). This means that this fiber most likely failed before the full proof-stress was achieved, that is, around the edge of the drum.

techniques and deductive reasoning. For example, a foreign particle is shown attached to the silica fiber in Fig 5. The flaw severity was not so easy to determine for this attached foreign particle. The particle, which probably attached to the fiber during drawing, caused a small ($\sim 2 \mu\text{m}$) crack, most likely upon cooling, which subsequently led to failure. The size of this crack is in good agreement with the calculated $3 \mu\text{m}$ from Eq 2. Chemical analysis by electron microprobe was taken to determine the origin of the particle. The analysis shows the presence of magnesium and iron as well as silica (Fig 5C and D) which implies a dust particle. This type of defect can be avoided by drawing the fibers in a clean room.

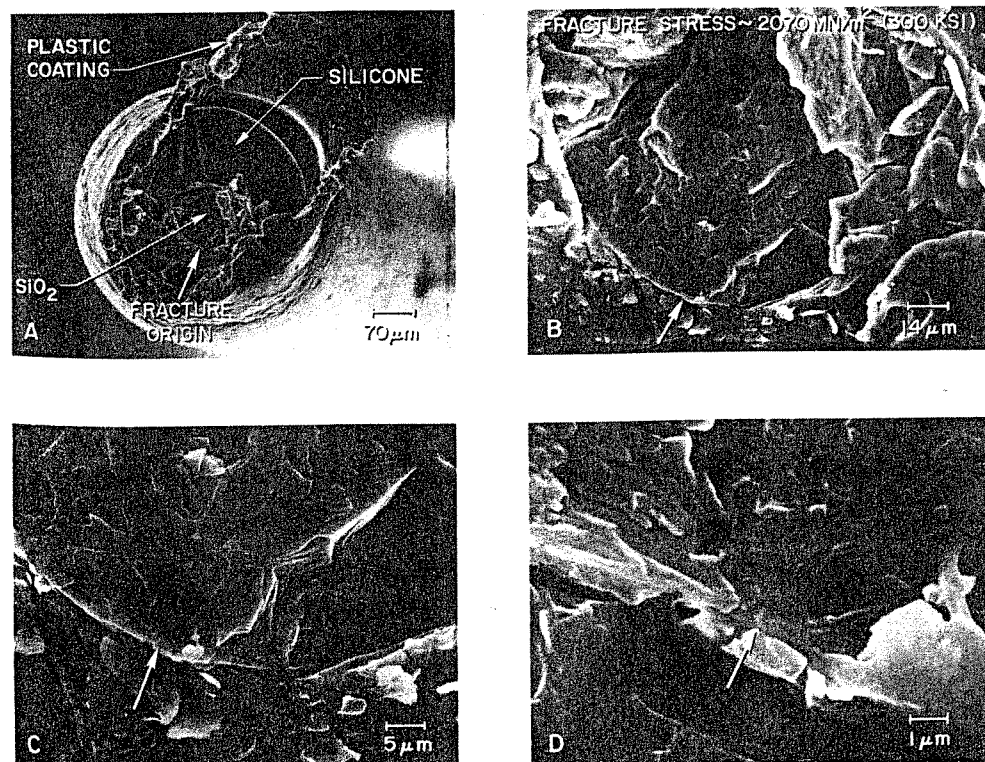
Fig 6 SEM fractographs of a fiber failed from the surface. The nature of the rough area surrounding the origin (arrow in B, C, and D) indicates a high stress (~2700 MPa, or 390 ksi). The exact nature of the fracture origin is unknown, but could be due to a thermal expansion mismatch between two phases (that is, glassy SiO₂ and crystalline SiO₂, or crystalline metal, or crystalline alumina).

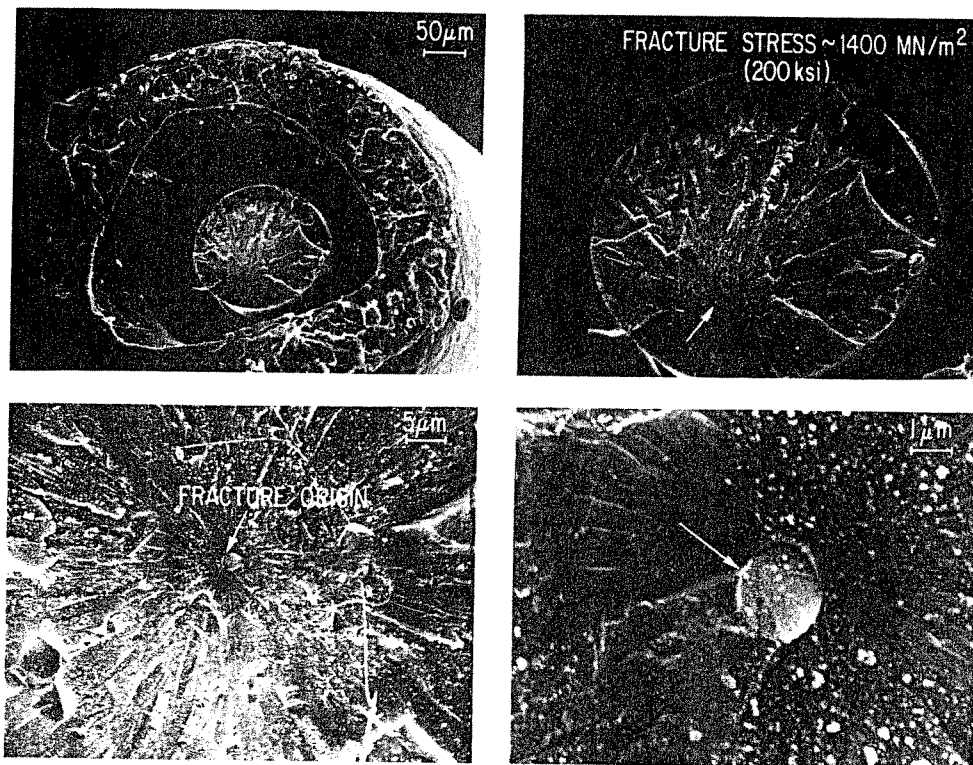
Fig 7 SEM fractographs of a polymer-coated fiber showing failure from a crack at the interface between a rare earth (Nd and La) inclusion and the bulk SiO_2 fiber. The size of the fracture "mirror" region surrounding the origin agrees with the 1400 MPa (200 ksi) proof-stress.

Although most fractures were from surface origins, there were seven cases with internal origins. One internal origin was an inclusion containing rare earth elements (neodymium and lanthanum) (Fig 7). This failure occurred due to a ($0.2 \mu\text{m}$) crack formed between the inclusion and bulk SiO_2 . Failure from inclusions related to natural-forming elements can most likely be eliminated by using synthetic quartz material rather than natural quartz. This also applies to preform manufacture used in the chemical vapor deposition (CVD) process. If the outer tube or preform material is natural quartz, then defects such as bubbles and inclusions will be transferred to the final silica fiber. Higher magnification was required to determine the source of these failures because the size of the defect, in most cases, was less than $0.2 \mu\text{m}$, and, consequently, detailed analysis was difficult.

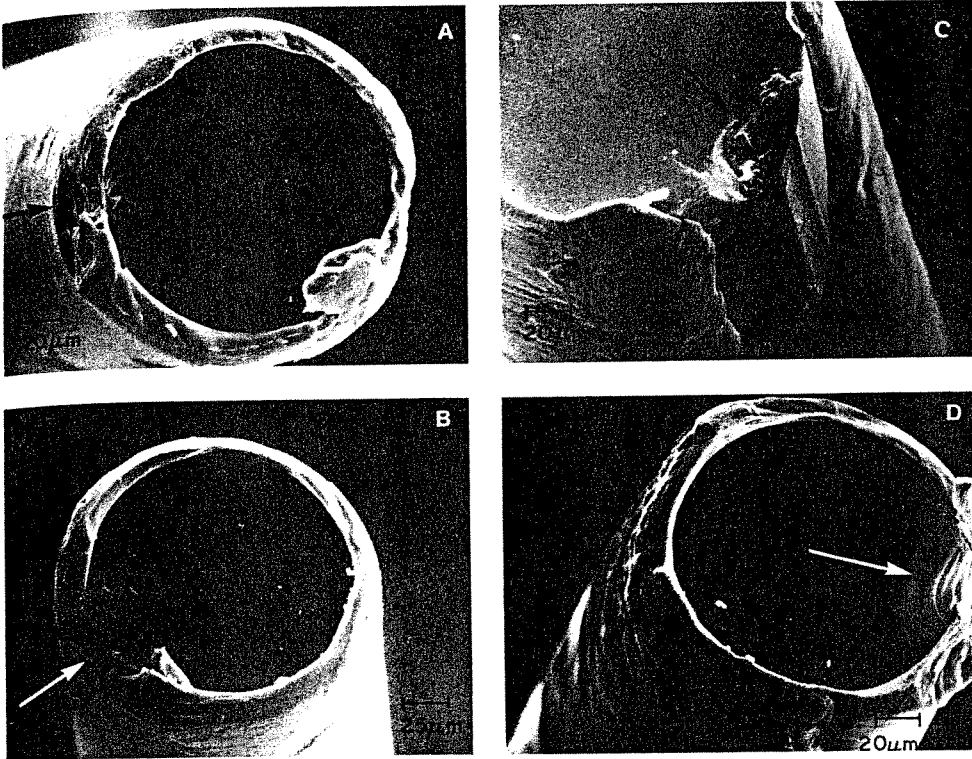
Research and Production Aids. In addition to the last two examples given above (Fig 5 and 7), there are two other examples which point out the usefulness of fractography in developing strong optical fibers. One of these cases involves identification of fracture origins in several low-strength fibers. A semielliptical trough on the surface of most of the fibers examined was consistently the location of the failure (Fig 8). Because the ridge along the fiber surface was relatively smooth, it would appear that this defect was produced in the drawing process when the fiber was relatively hot. If the fiber were cool, one would expect a rough gouge if some object were pulled across the surface. Further communications between the failure analysis laboratory and the supplier determined that most probably a ZrO_2 particle adhered to the fiber drawing die orifice and scribed a trough on the hot silica fiber during drawing. The supplier eliminated this type of problem by removing the ZrO_2 tube from the drawing process.

Fig 8 SEM fractographs of four metal-coated fibers failed in a proof test at relatively low strengths. Notice that all fibers indicate surface failure from an elliptical groove with ridge. The smoothness of the depression in B and C would indicate this occurred while the fiber was soft. Also, most likely, the metal is debonded from the fiber in the area around the defect in B and C.

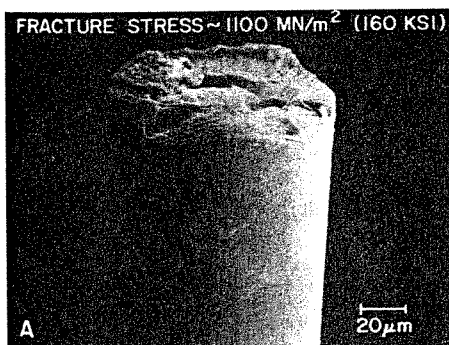
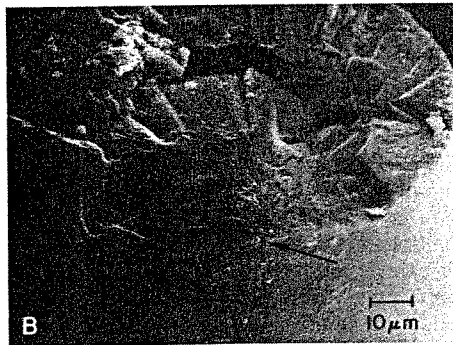
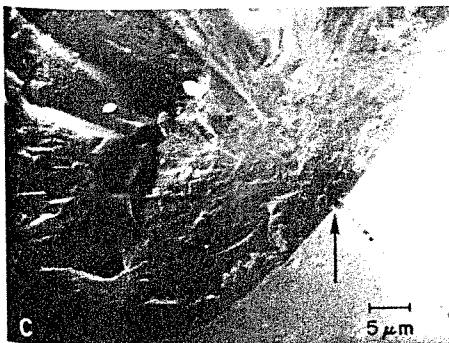
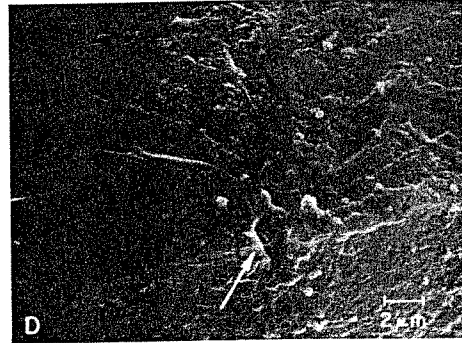
Another example of fracture due to production procedures is shown in Fig 9. Failure is seen to originate at a "bubble" which is one of many along the surface of the fiber. The bubbles along the surface indicate that a large bubble in the preform was drawn out during fiber pulling. The large defect size at the origin ($38 \mu\text{m}$ half width), resulted in

Fig 9 SEM fractographs of a fiber after removal of the metal coating. Source of failure (arrow) is from an elliptical defect, most likely from a bubble in the preform that was drawn out with the fiber.

approximately 1100 MPa (160 ksi) (from mirror-measurements) breaking stress in reasonable agreement with the approximately 1400 MPa (200 ksi) measured during the test. This emphasizes the need for good-quality preforms, if good-quality fibers are to be obtained.
