INTERPRETATION OF FRACTURE PATTERNS-

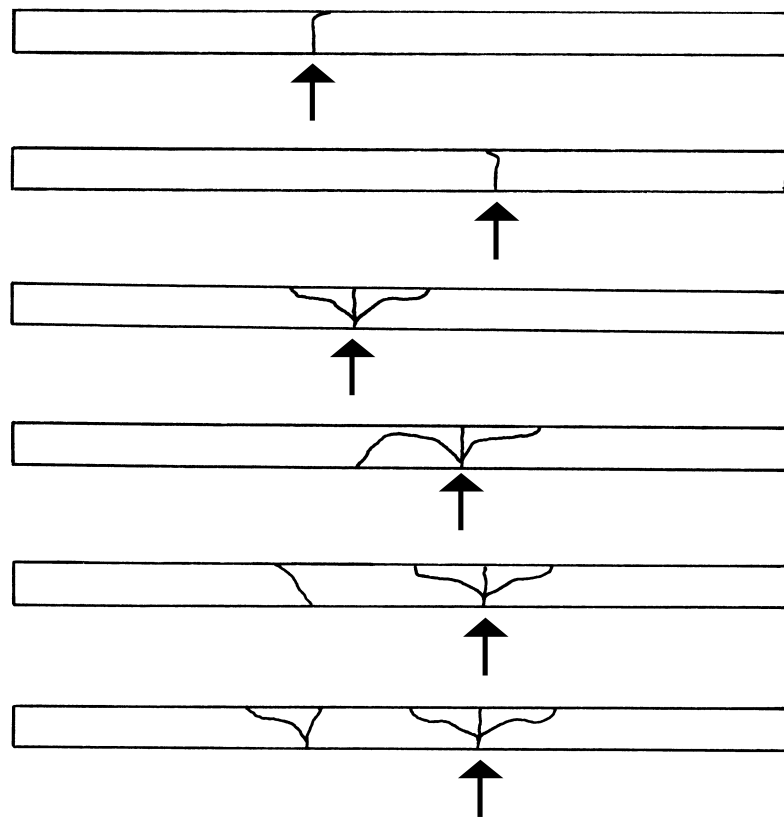
A3.1 Fracture patterns in rods broken in four-point flexure. Primary fractures (arrows) usually run at right angles to the specimen long axis and also have small or large cantilever (compression) curls on the compression side. Secondary breaks often are slightly non perpendicular to the specimen axis and are caused by reverberations in the specimen. Occasional breakages at or near a loading point are not a problem.

A3.1 Figs. A3.1 and A3.2 show side views of rods fractured in four-point flexure. In general, the breakage patterns are similar to those observed for rectangular beams broken in flexure. Primary and secondary breaks can be distinguished without too much difficulty. Figs. A3.3 - and A3.4 show normal and abnormal (secondary) fracture surfaces in glass rods. Fig. A3.5 shows an overall view of a properly tested specimen and how the compression (cantilever curl) can be used to confirm the orientation of the test specimen in the fixtures. See also Ref 5. for additional guidance on interpretation of fracture patterns.

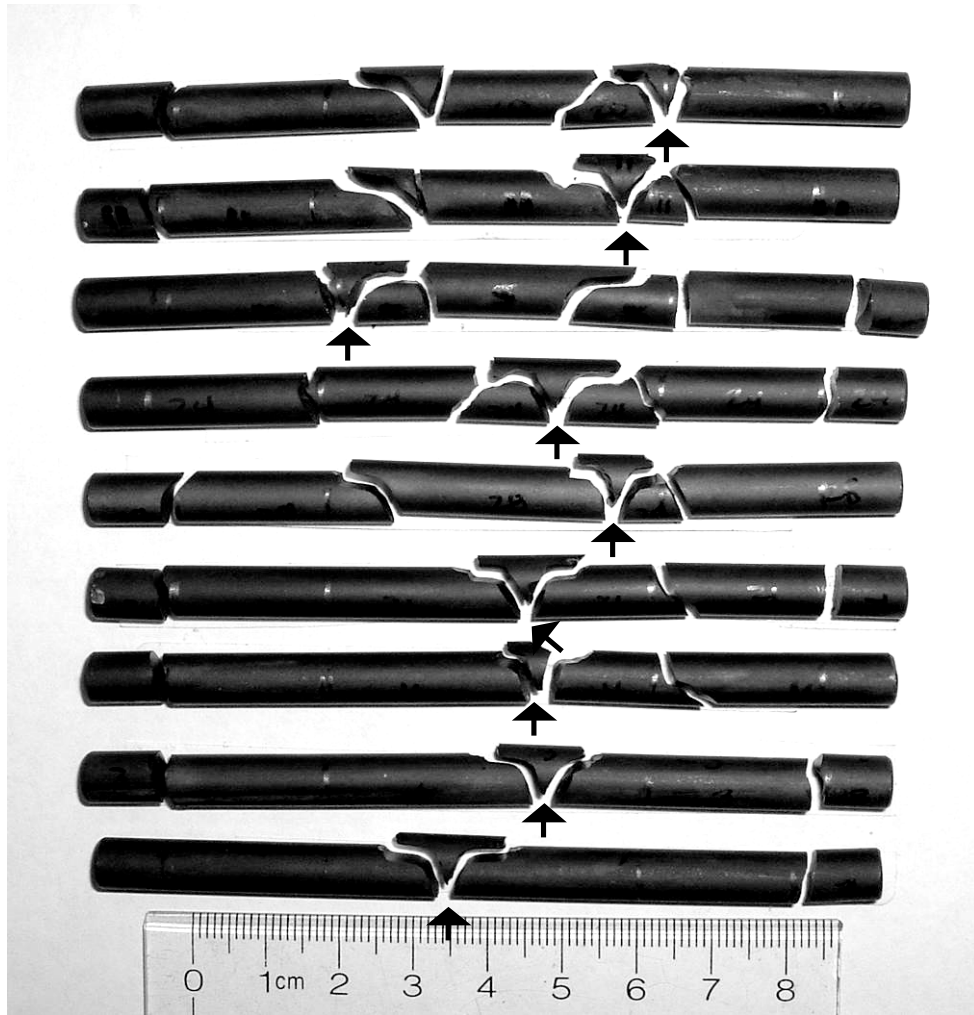
FIG A3.2 Fracture patterns in rods broken in four-point flexure. The arrows mark the primary fracture origins.

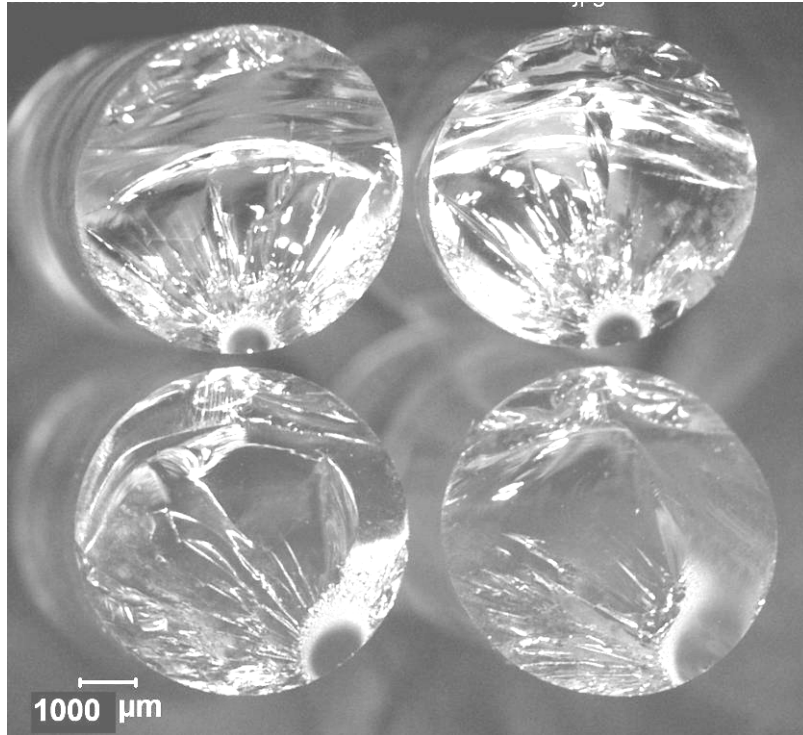
FIG. A3.3 Normal fracture surfaces in glass rods. Each rod has a fracture mirror. The maximum tensile stress is at bottom center in each case. Origins are not always at the location with maximum tensile stress. Some origins are part way up the sides. Some of the mirrors are elongated due to the stress gradient.

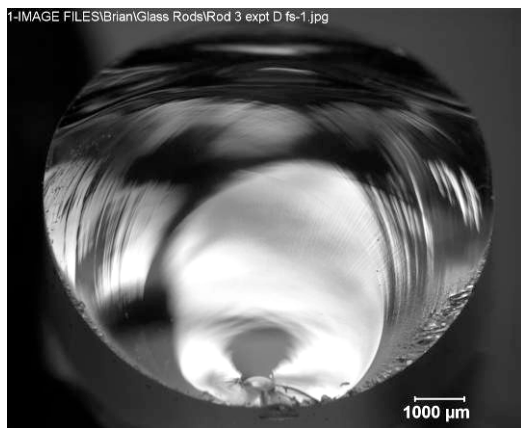
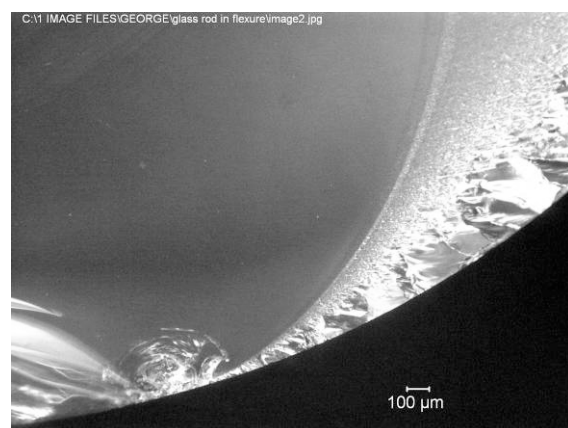
**FIG A3.4 Examples of abnormal (secondary) fracture surface in glass rods.
Reverberations of elastic waves after primary fracture has occurred can create such
secondary fractures.**

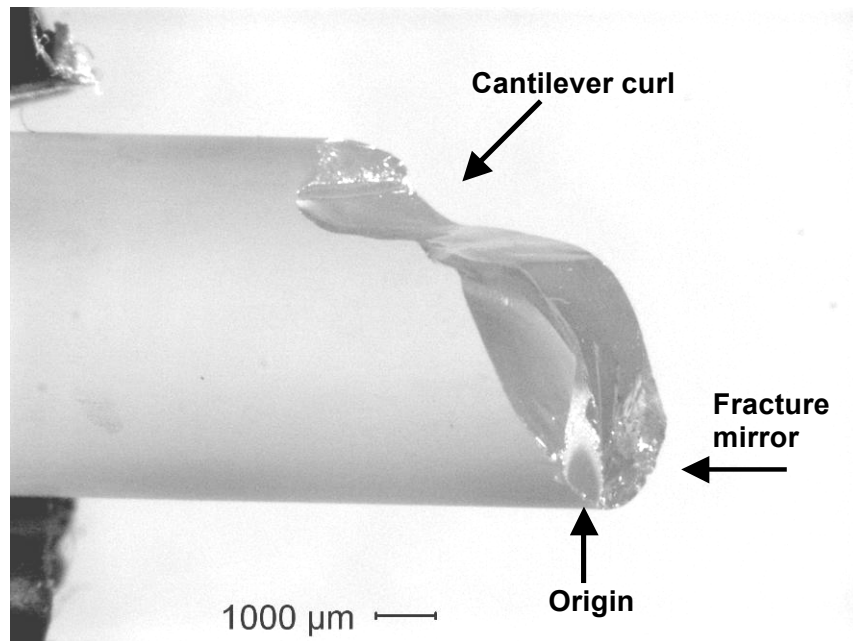
A3.5 Overall view of a glass rod fractured in flexure. The cantilever curl (also known as a compression curl) identifies the portion of the test piece that was in compression. It may be used to confirm the test specimen orientation in the fixtures after fracture. Notice that the origin and the fracture mirror were not at bottom center and were part way up the side of the rod. This is a normal and perfectly acceptable result.
